**Subject:** Bucks PH Outage 2020 Daily Status Report 07/13/2021

**Bucks PH Outage 2020 Daily Status Report: July 13, 2021**

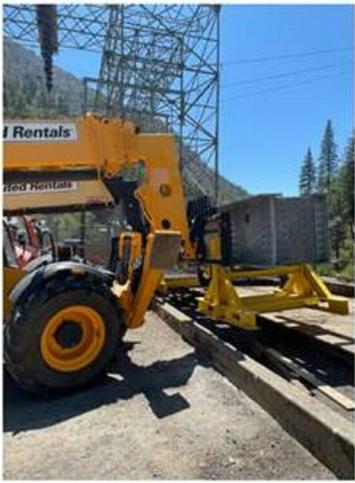
^Moving Spreader Beam

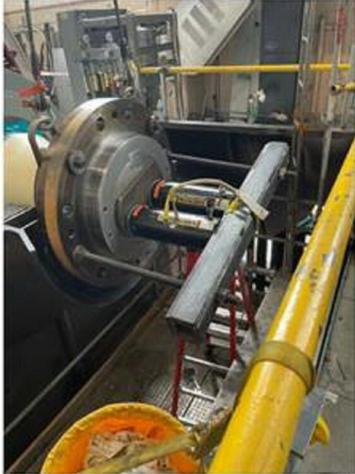
^Removable Hub Fixture

- GC DeSabra – continuing control room wiring, preparing for 52g-2 delivery
- GC Elec Techs – on hold until more work becomes available for unit 2
- GC Drum – setting up induction heating for removable hub removal, fabricating devices for hub removal
- TCB – mobilization & layout (onsite), stand fabrication (offsite), moved spreader beam
- PM – setting up TCB contract & budget for rotor repair, set up trucking & traffic control for runner move
- Eng – assisting removable hub removal, developing rotor repair quality plan, reviewing rotor/shaft lift plans from TCB
